Manhole Inspection Summary

Manhole # S25CC1009MH

Insp Date: **1/25/07 10:45 AM**

Location Address: **1300 DELLWOOD AVE**

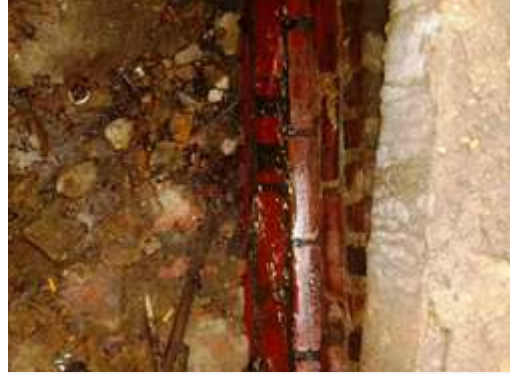
Top View

Evidence of surcharge - Bench debris.

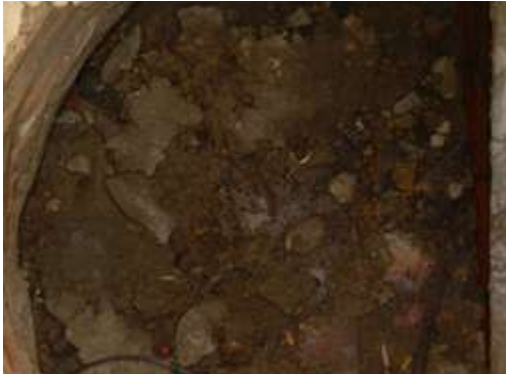
Defect

Bench debris.

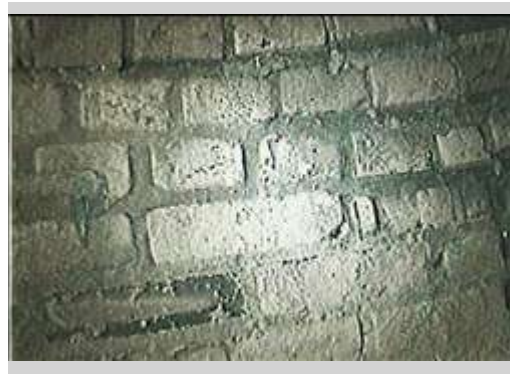
Defect

Condition: ☐ Sound ☐ Cracked ☐ Root Intrusion ☐ Loose Brick ☒ **Deteriorated**

Infiltration: ☐ None ☐ Joint ☐ Cracks ☒ **Mortar** ☐ Roots ☐ Wall

Barrel deterioration and infiltration.

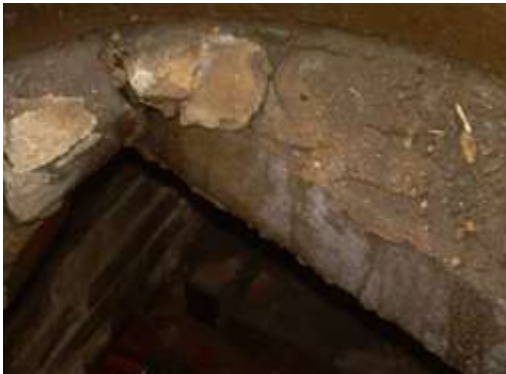
Condition: ☐ Sound ☐ Cracked ☒ **Leaks**

Condition: ☐ Sound ☐ Cracked ☐ Root Intrusion ☒ **Loose Brick** ☒ **Deteriorated**

Infiltration: ☐ None ☒ **Joint** ☐ Cracks ☒ **Mortar** ☐ Roots ☐ Wall

Frame leaks. Adjustment deterioration, loose brick and infiltration.

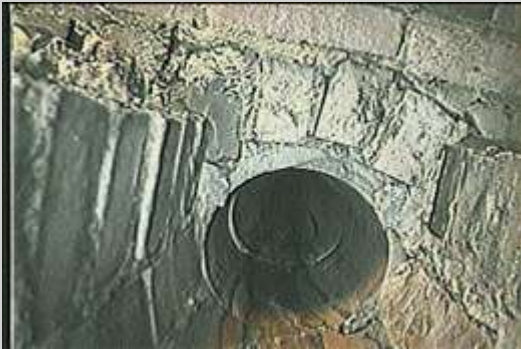
Pipe Out @ 12 O'Clock

Barrel deterioration and infiltration. Channel deterioration.

Infiltration: **Evidence** Pipe Seal Cond: **Cracked**
